General Investigation Research and Development Program

Flood-Fighting Structures Demonstration and Evaluation Program: Laboratory and Field Testing in Vicksburg, Mississippi

July 2007

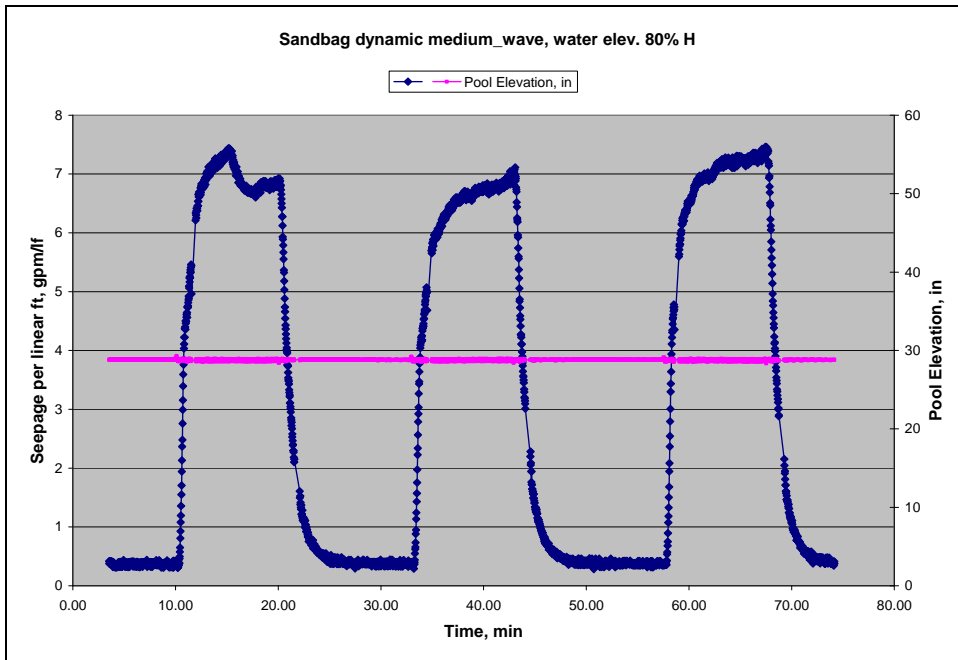
Figure 2-33. Seepage with dynamic testing at 80 percent levee height and 7- to 9-in. waves

Flow rate significantly increased from 0.38 to 7.42 gpm/lft due to overtopping of each wavefront. No displacement was observed. The amount of water going through and over the barrier is shown in Figure 2-33.

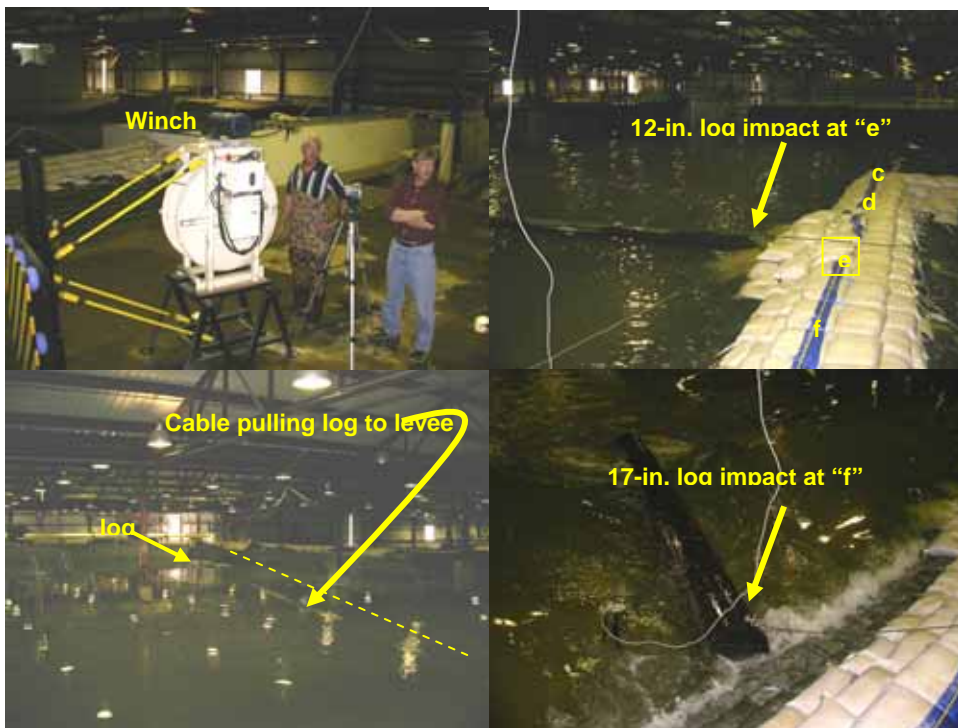
Figure 2-35. 12- and 16-in. logs at point of impact

The locations of impact are shown in Figure 2-35. The impact occurred at "e" for the 12-in. log and at "f" for the 16-in. log. No damage occurred from either log test, although the larger log left a small indentation on the barrier's front face. No permanent lateral displacement was observed during either test, and no vertical deformation was noted.

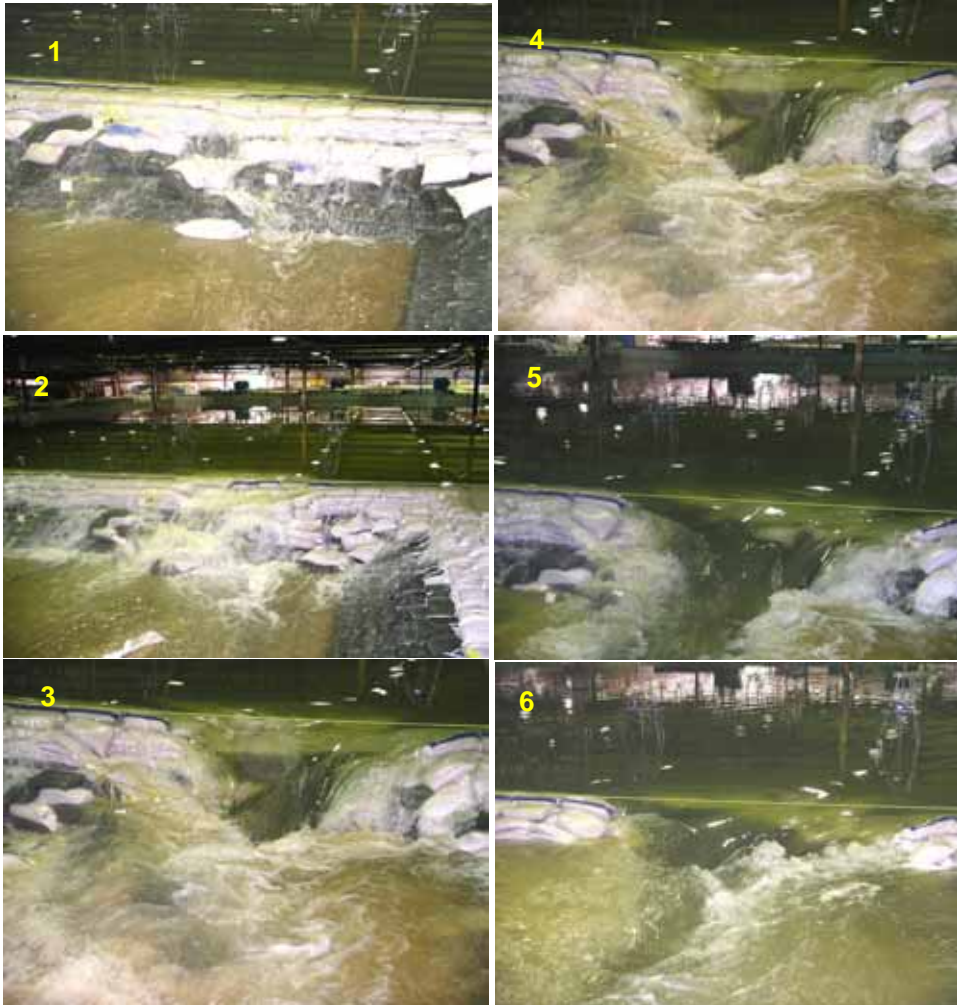
Figure 2-38. Sandbag levee progressive failure while testing

The levee failed during overtopping before the pool elevation reached 37.5 in. The pumping rate continually increased until failure occurred. Thus, the structure failed before the test criterion was reached. Figure 2-37 shows the structure prior to testing. Figure 2-38 shows the progressive failure during overtopping. Figure 2-39 shows the sandbag levee after failure. The autopsy of Figure 2-40 shows that the bags became filled with water by the wave action and emptied as the sand flowed out like water (liquefaction). The wave action caused the untied bags to empty. Once the sandbags became light enough, the waves washed the bags from the levee causing failure. Some of the bags found on the landside were completely empty.

However, the pool overtopped the levee at an elevation of 37 in. (approximately 1 in. above the crest), and continued for a period of 5.7 min. Progressive levee failure occurred as the total flow rate increased from 30.3 to 96.0 gpm/ft. A total flow rate of 2450 to 7,760 gpm is shown in Figure 2-36. Failure and results of failure are shown in Figures 2-37 through 2-40.

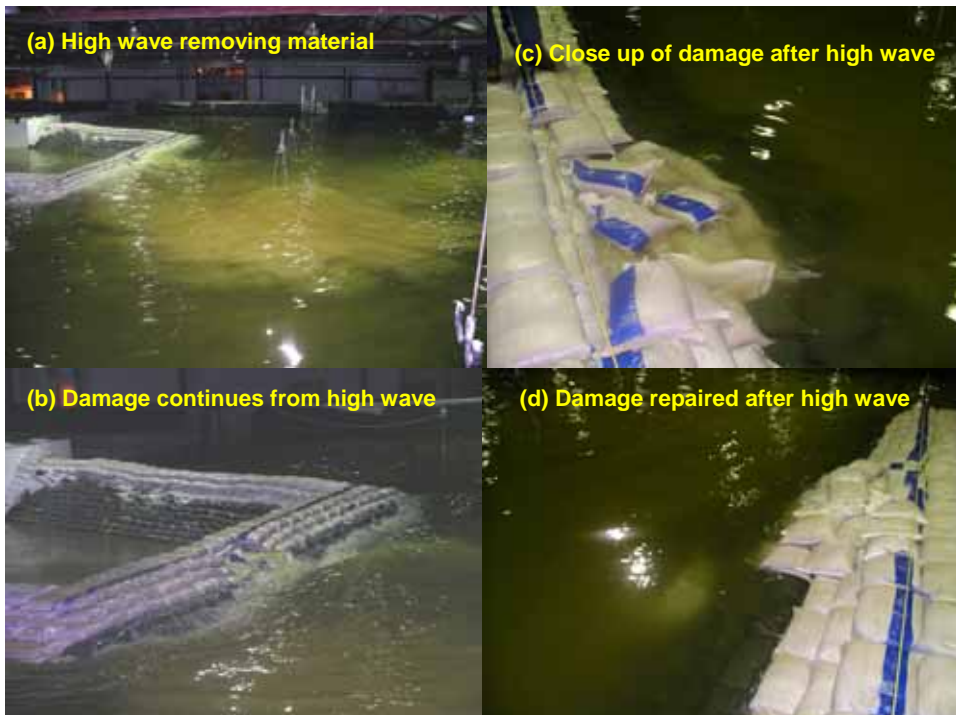
Figure 2-41. Sandbag levee damage and levee after field repair 1

The levee experienced damage at the center section. Sandbags were pulled back into the pool as the waves overtopped and water rushed back into the pool as the waves moved back toward the wave machine. Figure 2-41 shows the levee during the test, the damage after the test, and the levee after Repair 1.

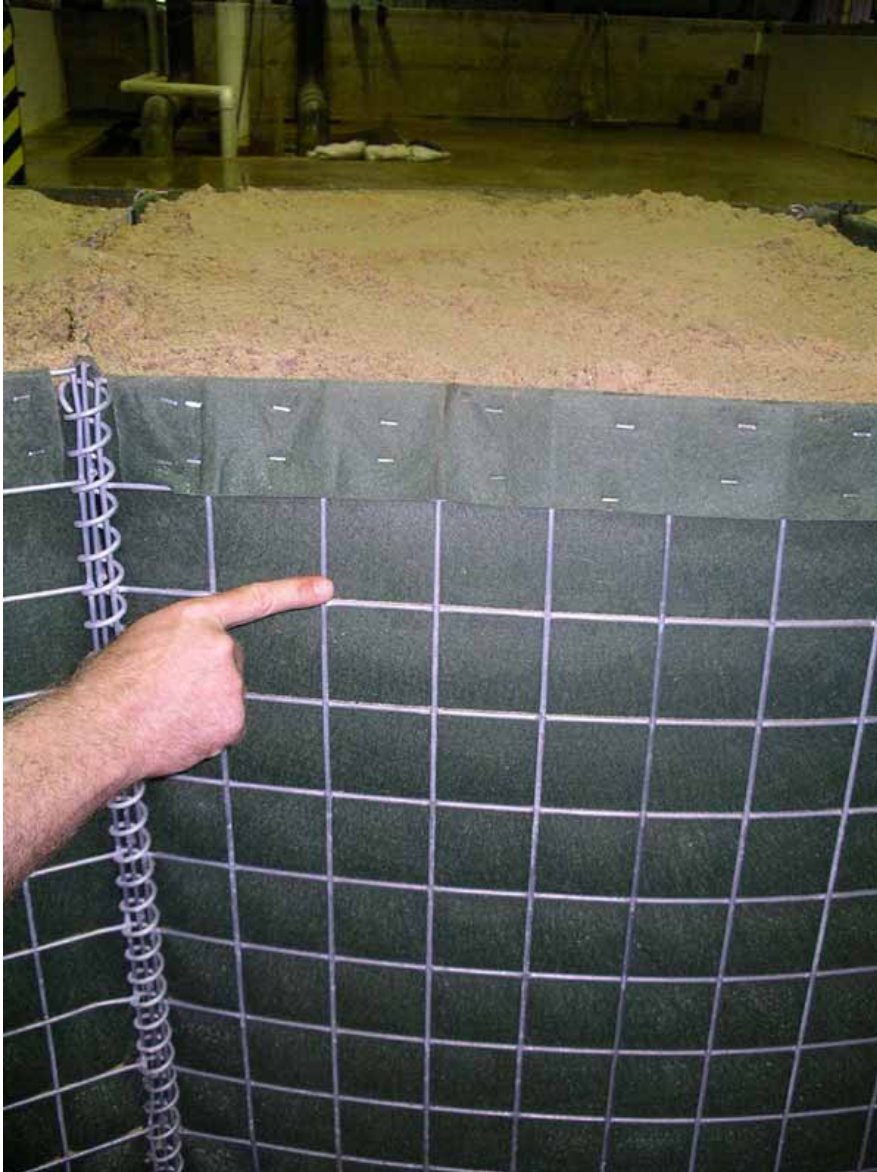
Figure 2-86. Log impact zone on center wall, pool side

With reservoir level at 24 in., the log impact tests were begun. The 12-in. log impacted the structure and bounced back without causing noticeable damage. The structure displaced slightly and recovered to its original position. The 16-in. log impacted the structure and bounced back also without causing any noticeable damage. The structure displaced slightly and recovered to its original position, but vertical deformations of the sand fill ranging from 4.02 to 0.72 in. were noted. Figure 2-85 shows the minor change in seepage flow rate during impact testing and Figure 2-86 shows the area where the logs hit, viewed from the pool side.

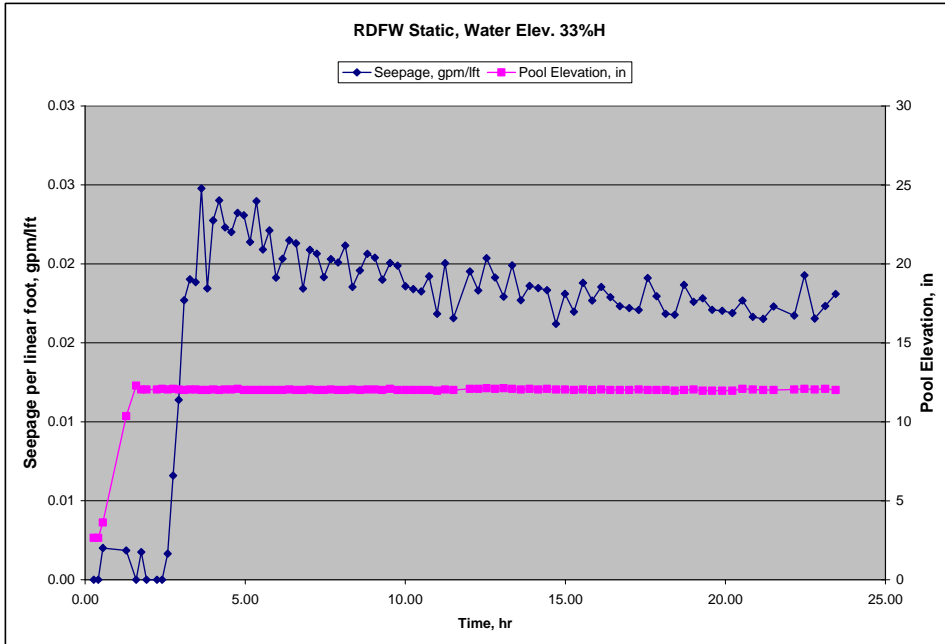
Figure 2-125. Seepage flow rate per linear foot at 1-ft pool elevation

Hydrostatic head test, 1-ft reservoir (33 percent height). The water level in the reservoir on the pool side of the levee was raised to a height of 1 ft (33 percent of levee height). Seepage flow rate was measured in the range from 0.017 to 0.025 gpm/ft (Figure 2-125), and no displacement was observed. Figure 2-126 shows the view from the pool side, including the lateral-displacement-monitoring system over the center wall. Figure 2-127 shows the view from the protected side, and Figure 2-128 is a view along the left wall.
